CULTURAL RESOURCES SURVEY FOR THE INTERSTATE 495 EXPRESS LANES NORTHERN EXTENSION PROJECT

VDOT PROJECT: 0495-029-419, P101
IPM/UPC/CSC NO: 113414
VDHR FILE NO: 2018-0473

FAIRFAX COUNTY, VIRGINIA

FINAL REPORT
JUNE 2019

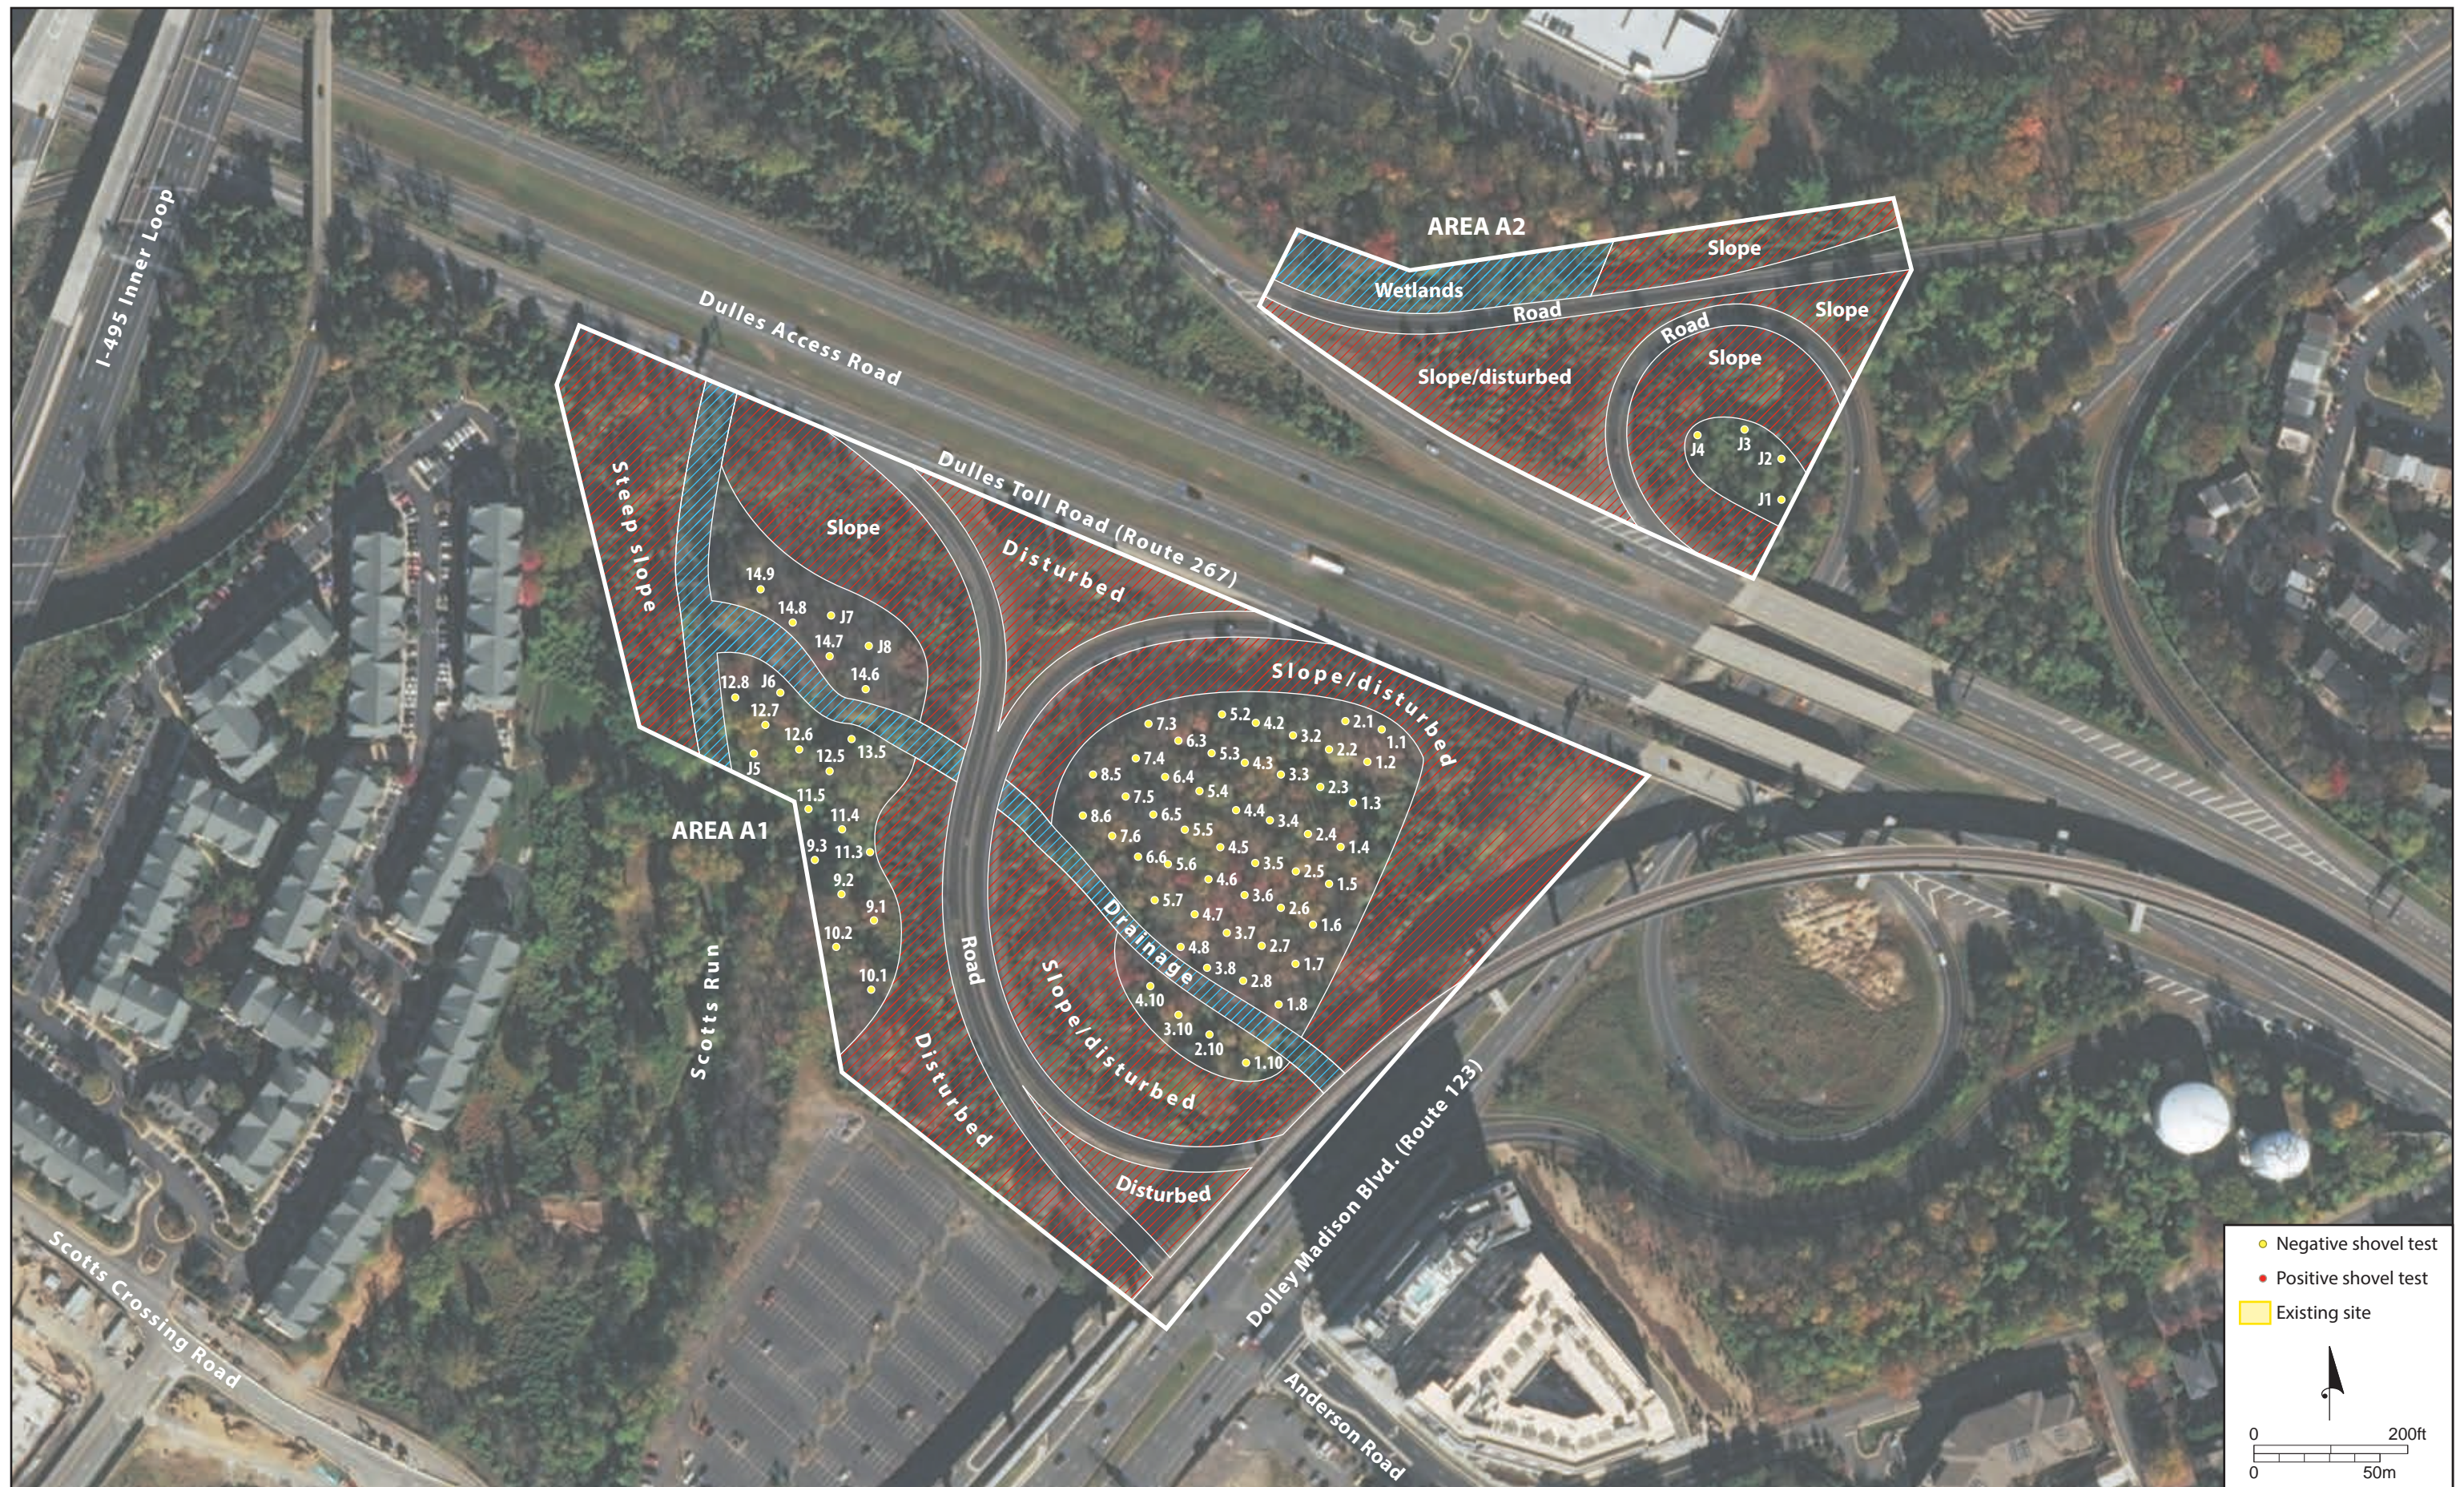
Figure 7. Aerial photograph showing the location of Survey Areas A1 and A2, shovel tests, and disturbed and sloping areas.

Survey Area A1 is located to the southwest and Survey Area A2 to the northwest of the intersection of the Dulles Toll Road (Route 267) and Dolley Madison Boulevard (Route 123) (Figure 7). Area A1 was tested with 71 STs and a walkover survey. The APE within Area A1 consisted of wooded areas, drainages, and roadside disturbance. The portion of Area A1 adjacent to Dolley Madison Boulevard contained a gravel pull-off area and disturbed soils associated with the construction of the roadway and the installation of roadside utilities. The exit lanes to and from the Dulles Toll Road had been built up on steeply sloping artificial berms. Scotts Run crosses the APE within the western portion of Area A1, and an unnamed intermittent drainage runs southeast from Scotts Run through the eastern portion of the APE. An active homeless camp was located within the eastern portion of the APE. West of Scotts Run were very steep slopes leading up to a housing development. Soils within A1 are reported to include Codorus silt loam in the floodplain of Scotts Run, and Glenelg silt loam, Wheaton loam, Wheaton-Meadowville complex, and urban lands in upland areas. A typical ST profile consisted of an approximately 0.75-ft thick A horizon of 10YR 4/6 yellowish brown silty loam over a B horizon of 7.5YR 5/8 strong brown silty clay loam (Figure 13, ST 3.2). A typical ST profile in the floodplain consisted of an approximately 0.4-ft thick A horizon of 10YR 5/4 yellowish brown silty loam over an approximately 1-ft thick Bw1 horizon of 10YR 5/6 yellowish brown silty clay loam, over a Bw2 horizon of 10YR 5/8 yellowish brown silty clay loam (Figure 13, ST J6). No artifacts were recovered, and no subsurface features were identified.

Survey Area A2 was tested with four STs and a walkover survey. The APE within Area A2 primarily consisted of steeply sloping artificial berms surrounding a small wooded area in the center of the exit lane that leads from the Dulles Toll Road onto Dolley Madison Boulevard. Across this lane and to the west was a steeply sloping artificial berm leading down to the exit lane that leads from Dolley Madison Boulevard onto the Dulles Toll Road. Across this lane and to the north was a wetlands area with standing water observed at the surface and sloping areas leading down to an unnamed drainage that was located outside of the APE. Soils within A2 are reported to include Codorus silt loam in the floodplain, and Glenelg silt loam, Wheaton loam, and urban lands in upland areas. A typical ST profile consisted of an approximately 0.5 ft thick fill deposit of 7.5YR 5/4 brown silty clay loam over a B horizon of 7.5YR 5/8 strong brown silty clay. No artifacts were recovered, and no subsurface features were identified.

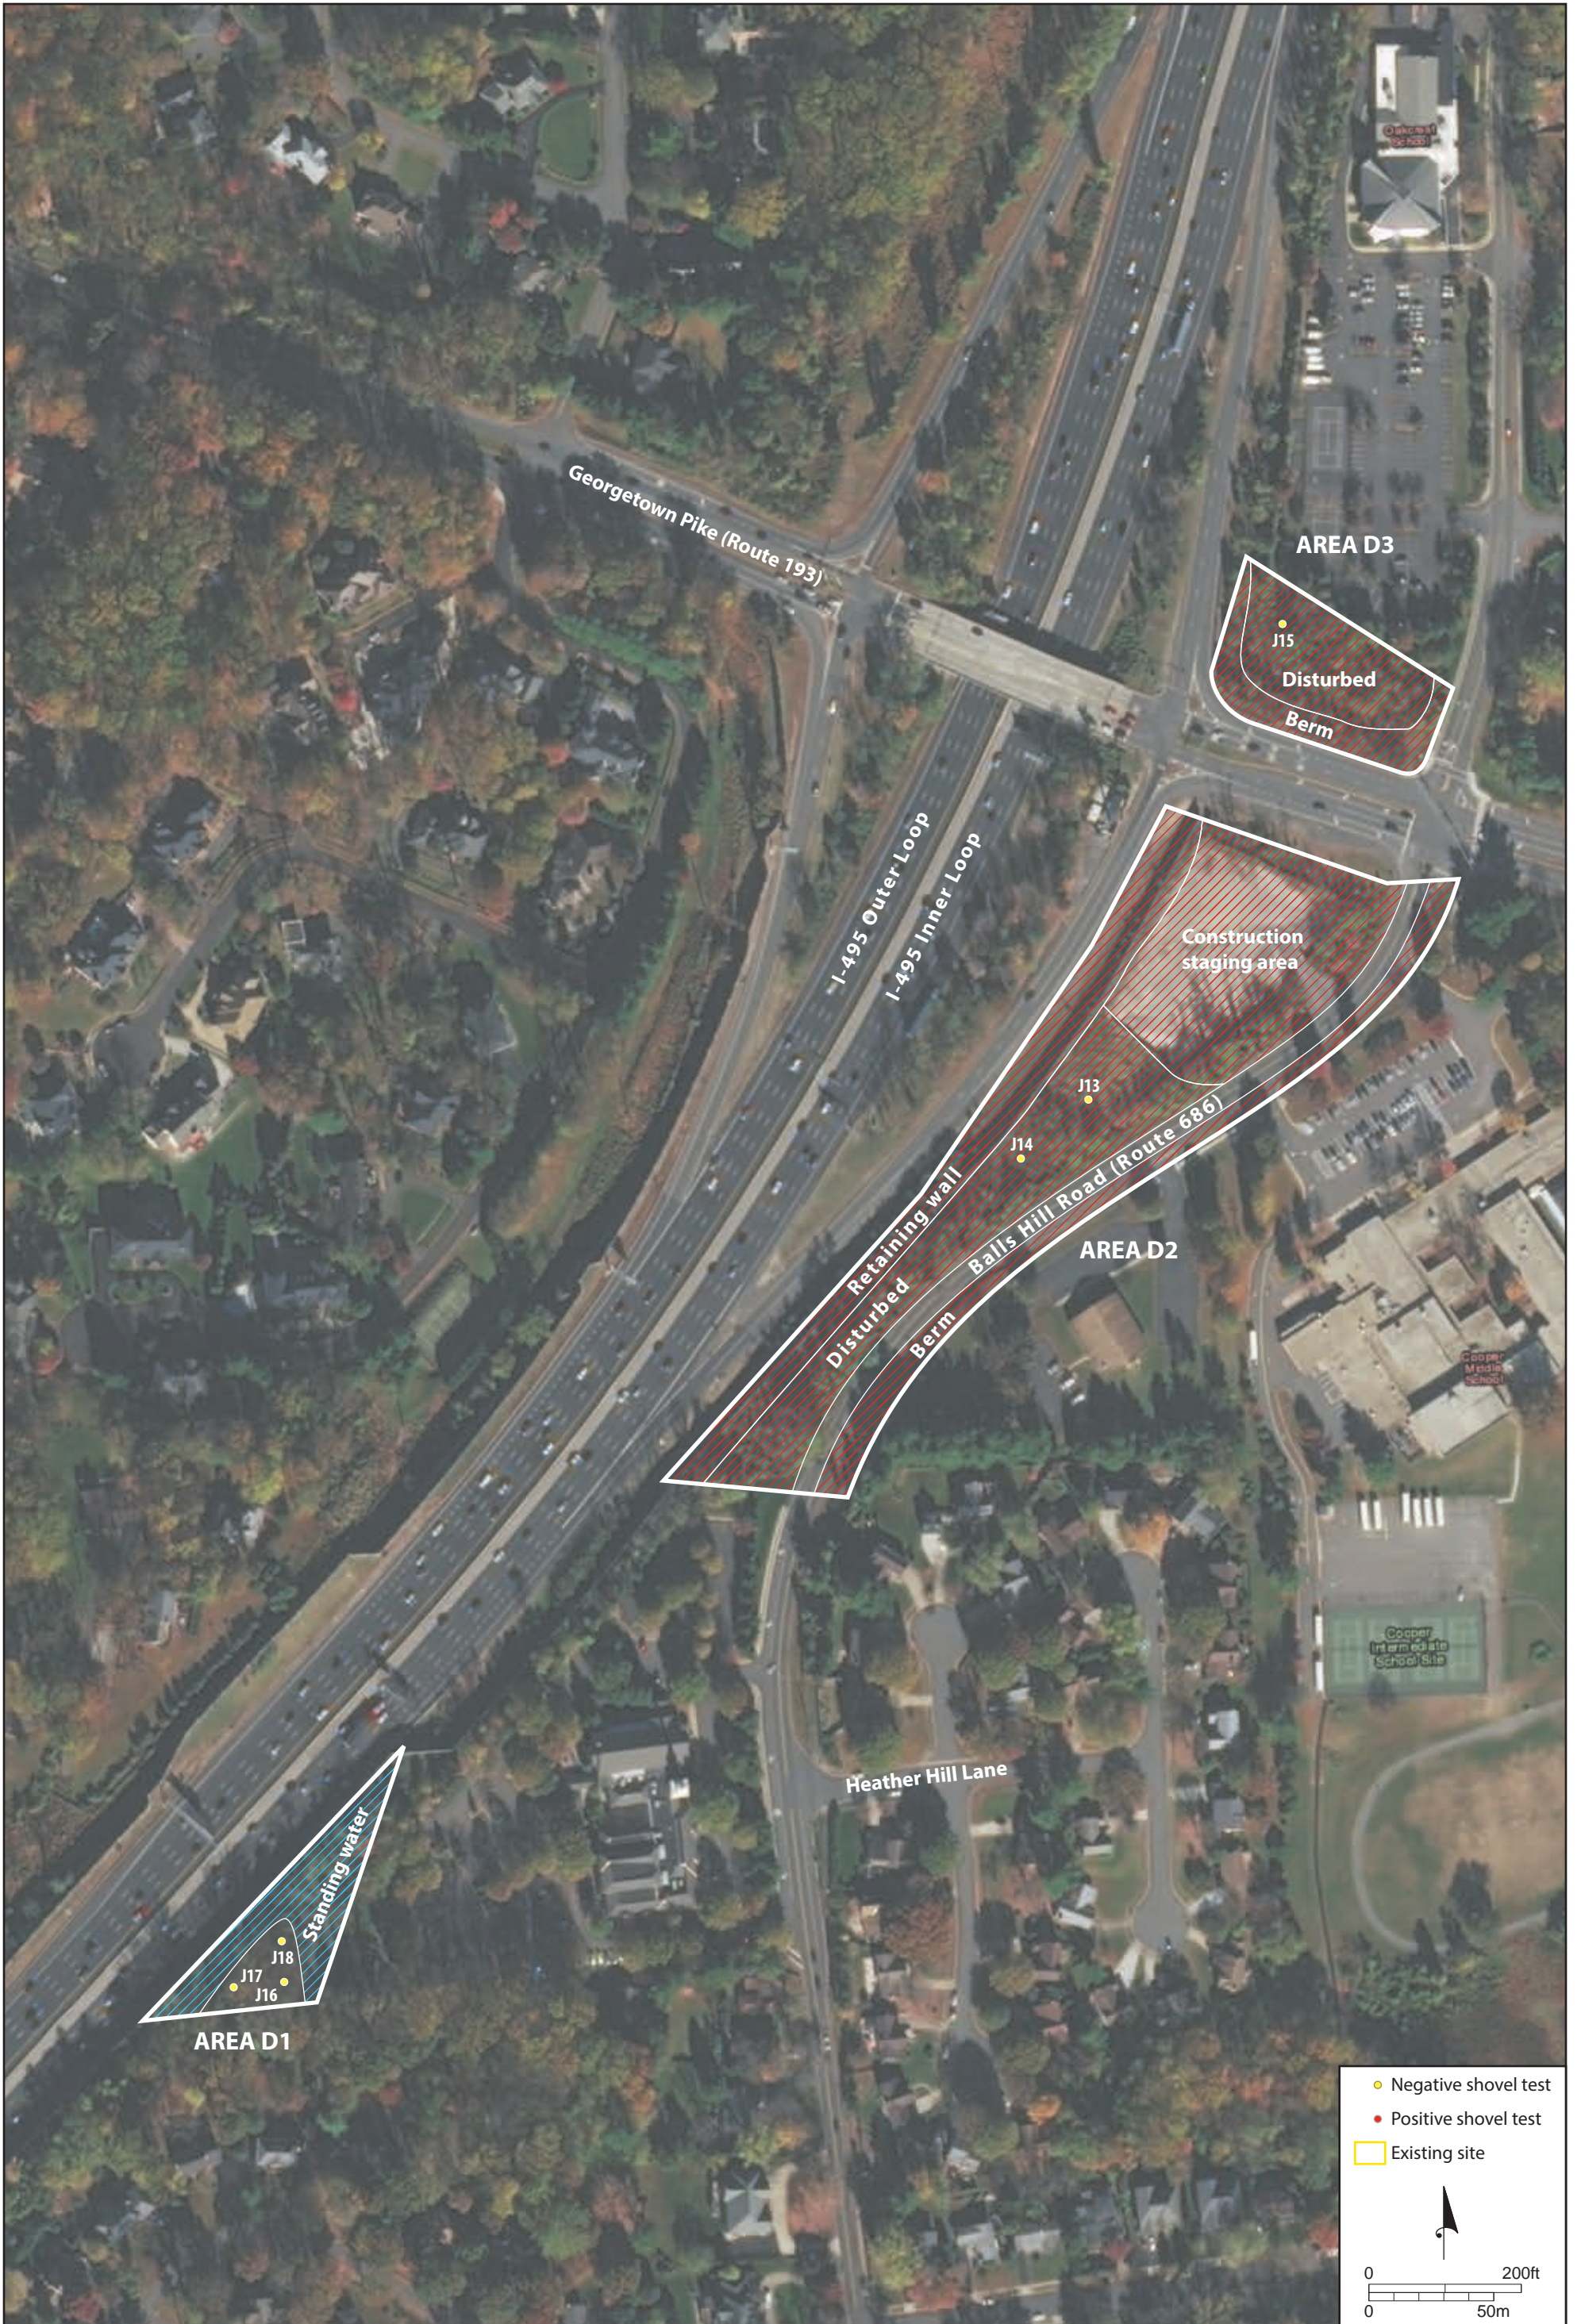
Figure 10. Aerial photograph showing the location of Survey Areas D1, D2 and D3, shovel tests, and disturbed and sloping areas.

Survey Areas D1 and D2 are located southeast of the intersection of I-495 and Georgetown Pike (Route 193) and along Balls Hill Road (Route 686) (Figure 10). Survey Area D3 is located northeast of the intersection of I-495 and Georgetown Pike. Area D1 was tested with three STs and a walkover survey. The APE within Area D1 consisted of wooded uplands and disturbed areas associated with the installation of a sound wall. A large storm water management feature is located just outside of the APE to the east, and standing water was observed at the surface within Area D1. Soils within Area D1 are reported to include Glenelg silt loam, Meadowville silt loam, and urban land. A typical ST profile consisted of an approximately 0.65-ft thick fill deposit of 7.5YR 4/3 brown silty clay loam over a truncated B horizon of 5YR 4/6 yellowish red silty clay loam (Figure 14, ST J16). No artifacts were recovered, and no subsurface features were identified.

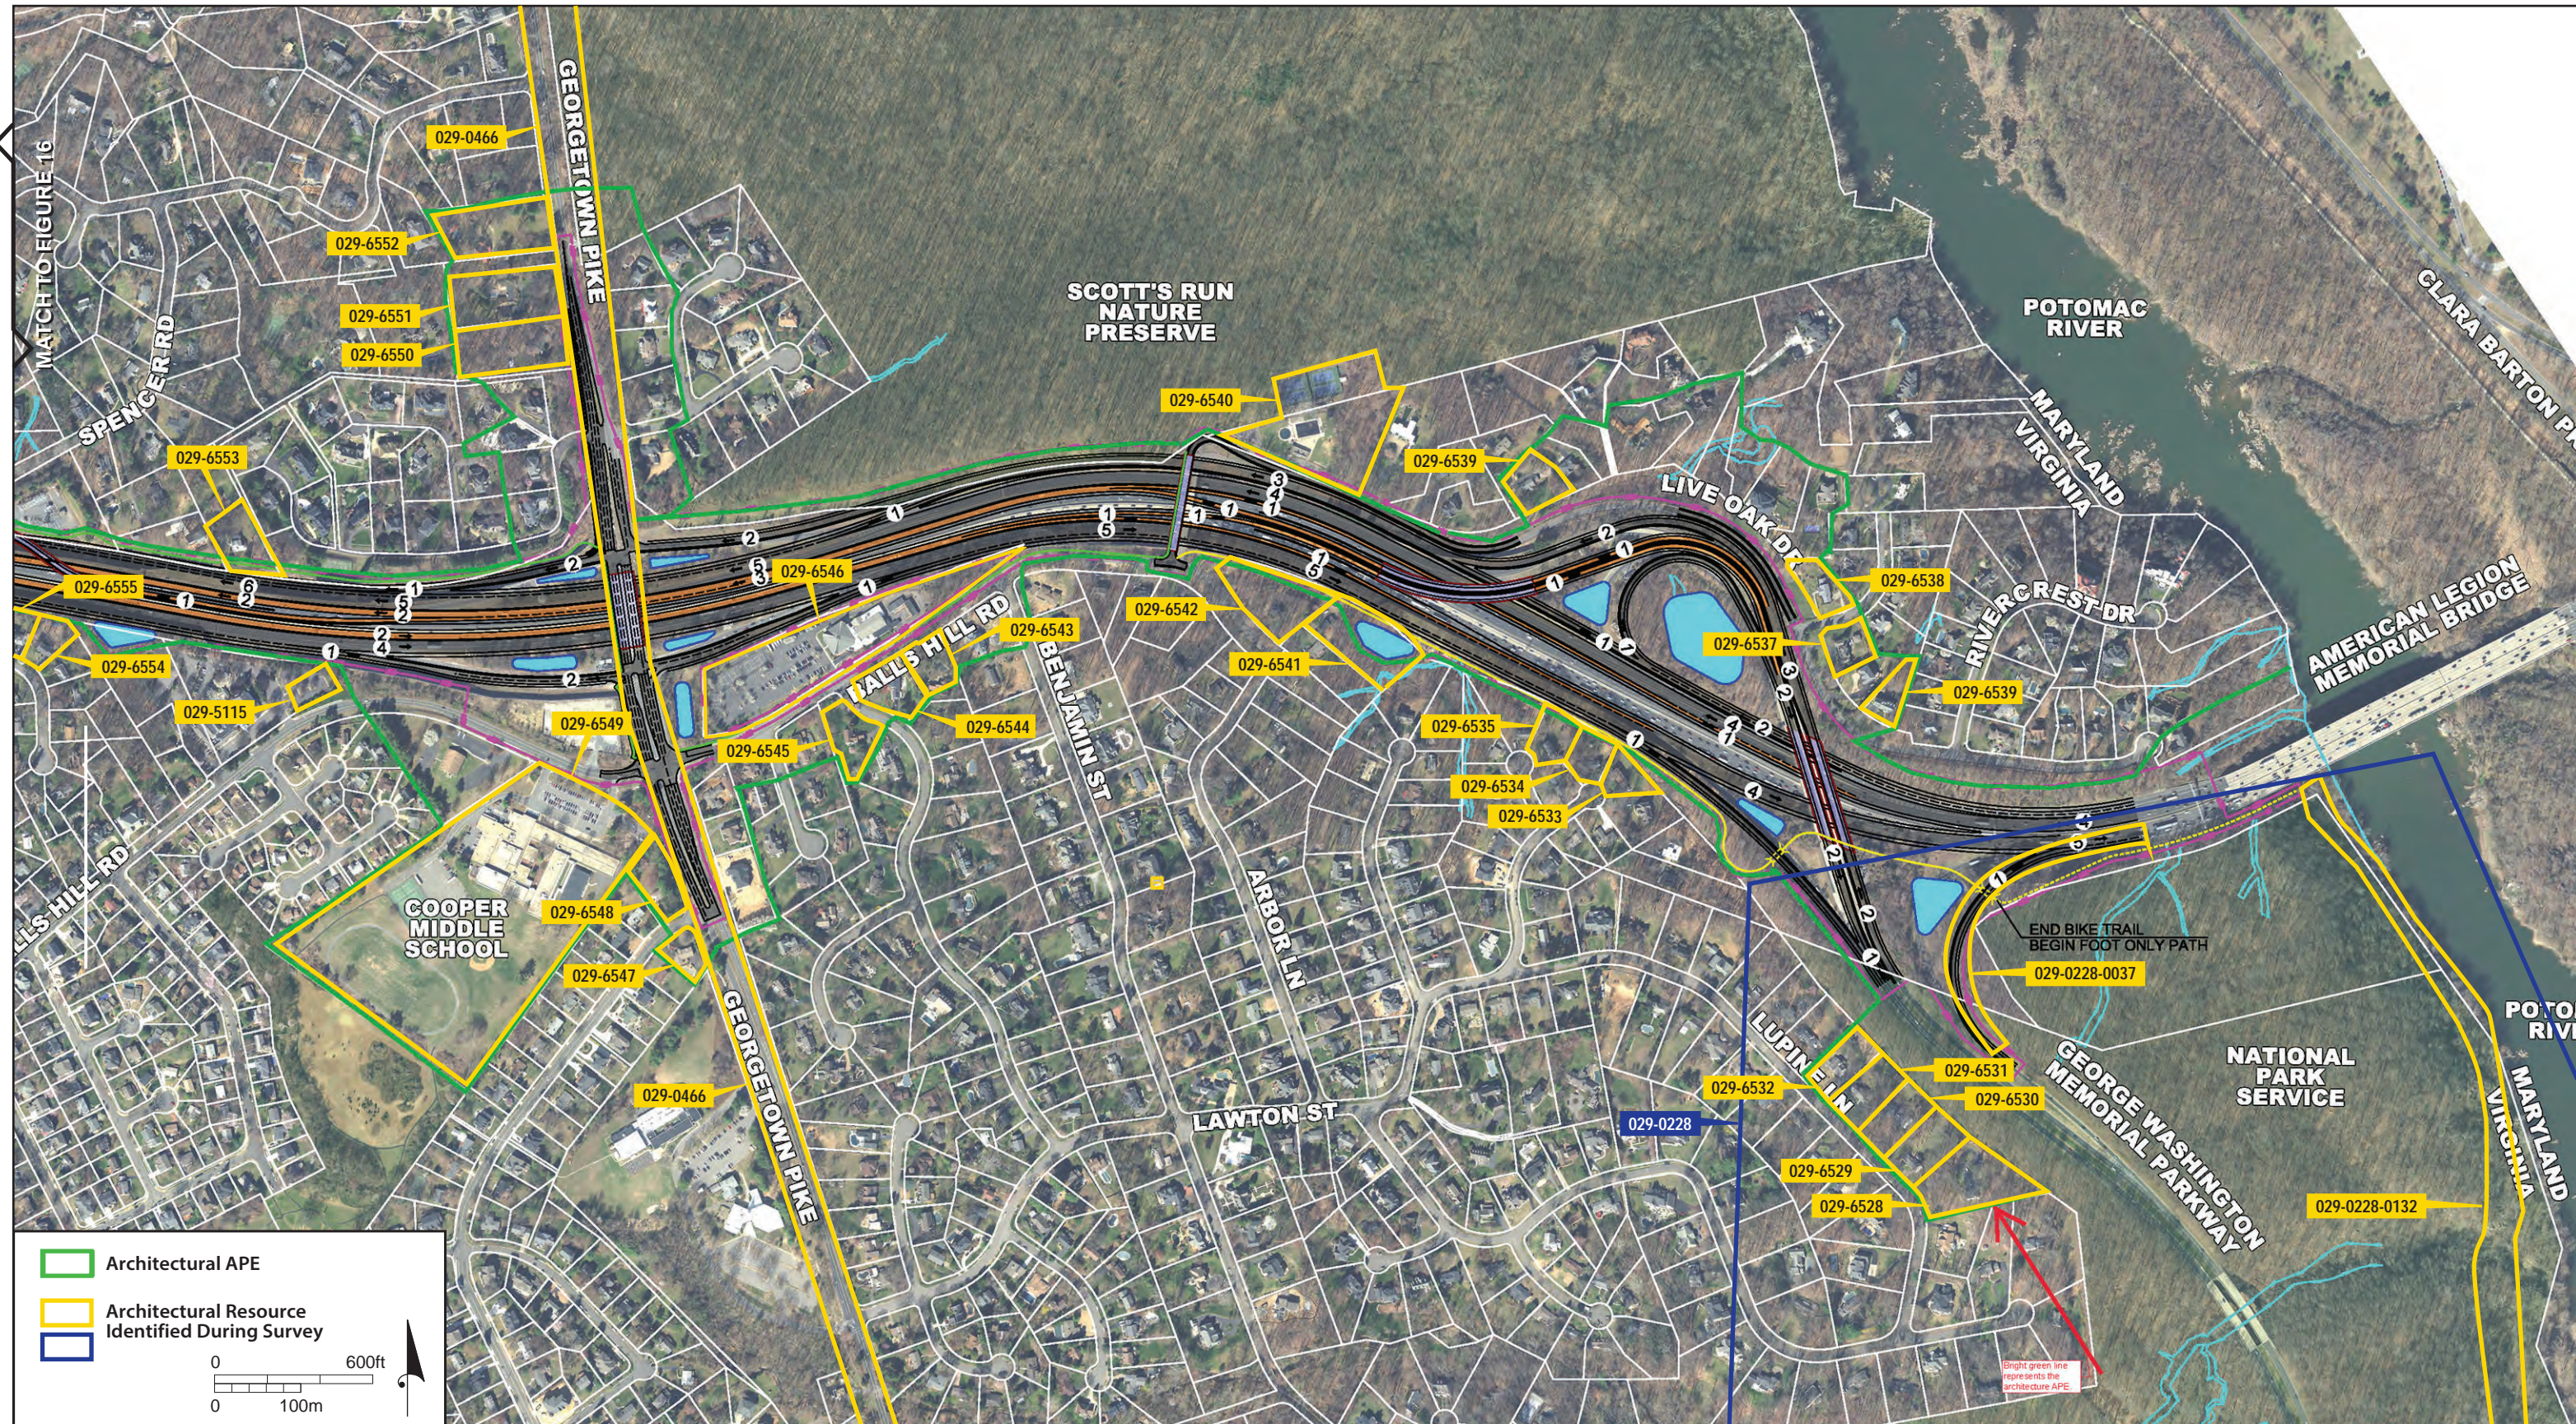
Figure 15. Architectural resources identified during the present survey.

The field investigation included the reconnaissance level documentation of 58 architectural resources, and within the APE for architecture (Table 7, Figures 15-16). Commonwealth recommends no change in the eligibility status for the three resources (029-0228, 029-0228-0037, and 029-0466) previously listed on the NRHP. For the three previously recorded but unevaluated resources (029-0228-0132, 029-5107, and 029-5115), Commonwealth recommends they not be considered eligible for listing on the NRHP due to a lack of significance and/or a loss of integrity.

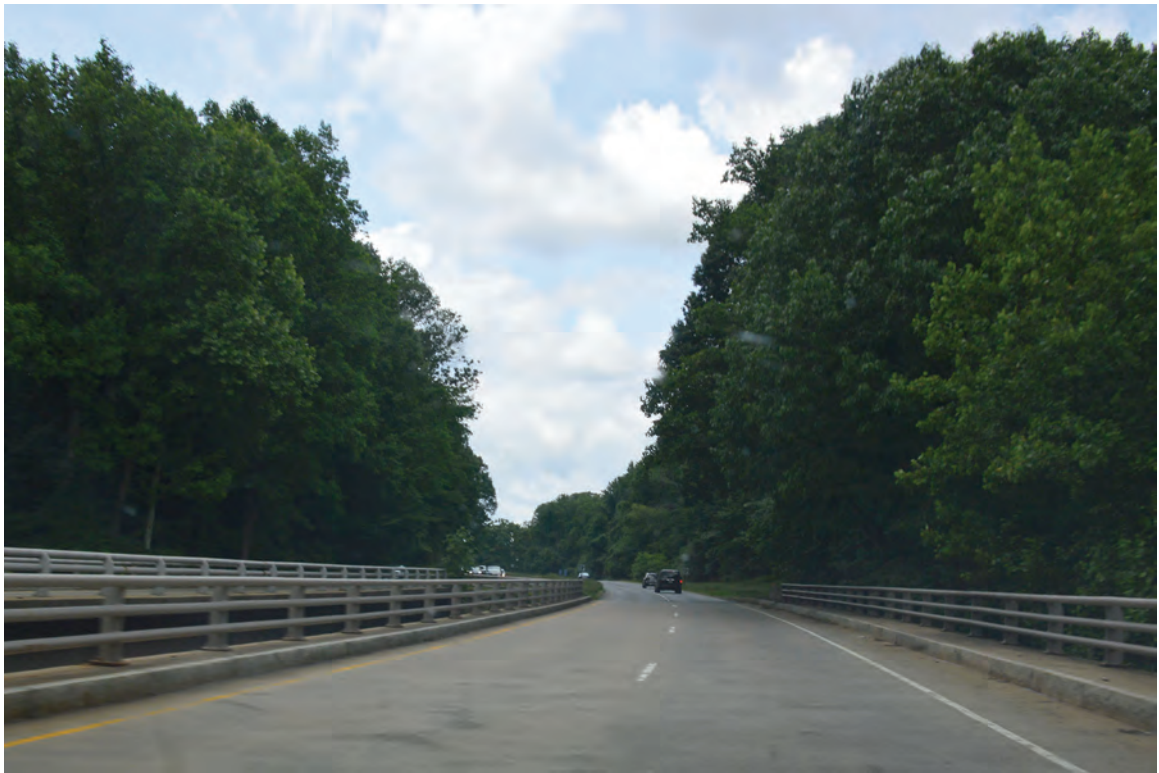
Only a small portion of the George Washington Memorial Parkway, the portion adjacent to I-495, was surveyed as part of this project (Figure 17). This road is paved with a divided roadway, with two lanes in each direction and a grassy median between. The road follows a roughly east-west orientation in this section. Entrance and exit ramps to and from the north- and southbound lanes of I-495 are present in this portion of the road.

Figure 17. George Washington Memorial Parkway (029-0228), view westbound from bridge over Dead Run.

The George Washington Memorial Parkway was listed on the NRHP in June 1995 under the Multiple Property documentation “Parkways of the National Capital Region, 1913 to 1965.” The parkway is significant for its landscape architecture and commemoration of George Washington. There have been no changes to the portion of the parkway documented during this survey that would alter its NRHP eligibility.

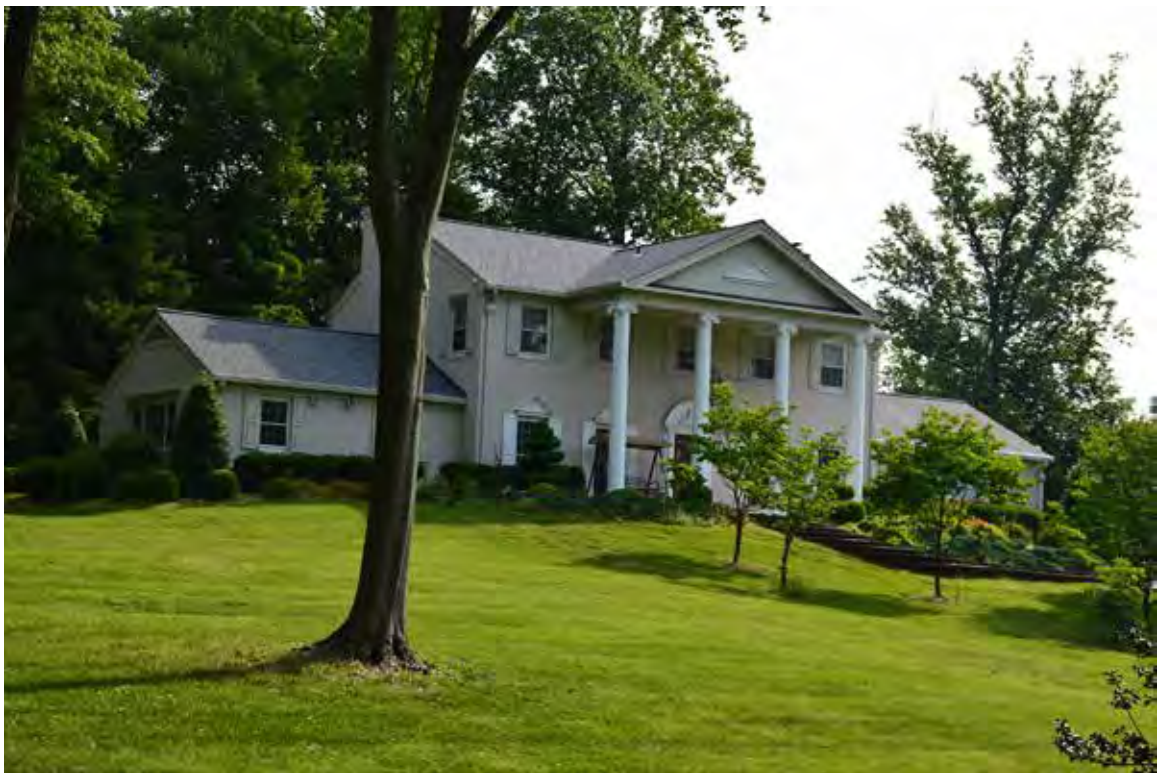
Figure 22. House, 7001 Green Oak Drive (029-6538), view to northeast.

This two-story tall Colonial Revival style house is on a sloping lot, leaving the basement which includes a garage, exposed on the east elevation (Figure 22). The two-story core of the house measures four bays wide and two bays deep. The core is flanked by one-story tall, side-gabled wings that are two bays wide and one bay deep. The exterior is stretcher bond brick and the side gabled roof is covered with asphalt shingles. Exterior, stretcher bond chimneys rise up the north and south gable ends. A two-story, gabled portico, supported by colossal Ionic columns shelters the central three bays of the façade. The main entry features a semi-circular pediment, while the first floor windows on the façade are each topped with a triangular pediment. The windows are one-over-one, double-hung sash with faux muntins and rowlock sills.

According to Fairfax County property assessment records, this building was built in 1968. It is not a significant example of the Colonial Revival style, as it has typical details such as the symmetrical core and wings, stretcher bond brick exterior, and two-story portico. This building is recommended as not eligible under Criterion C of the NRHP. It is not known to be associated with significant events or persons, and as an architectural resource is not recommended eligible under Criterion D.

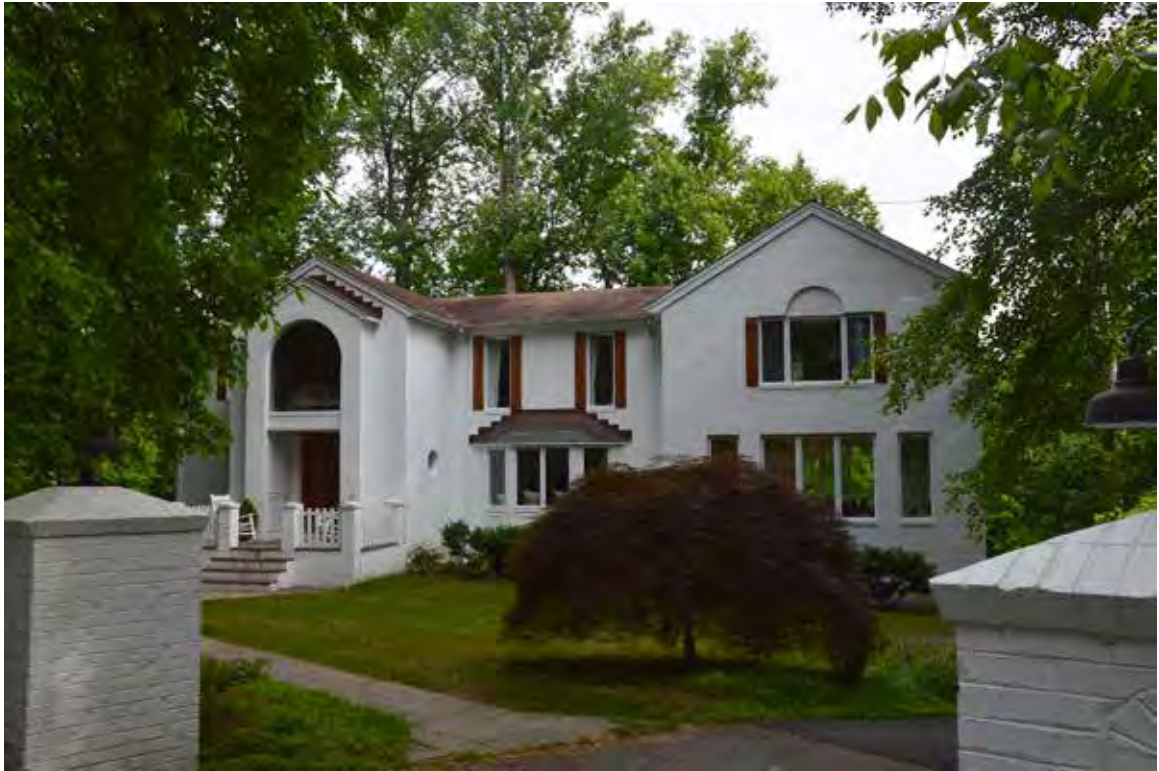
This two-story tall Contemporary style house has an irregular form with two, cross-gabled bays projecting from the core (Figure 28). The house has a stretcher bond exterior, with a double soldier course belt course between the first and second floors. The cross gabled roof is covered

Figure 28. 720 Lawton Street (029-6533), house, façade.

with asphalt shingles. The windows are a mixture of casement sash, bay windows, and picture windows. The windows feature rowlock brick sills and the second floor picture window in the northern bay is topped with an arched lintel. The main entry is within a recess in the southern projecting bay and is accessed by a deck with brick piers and picket railing.

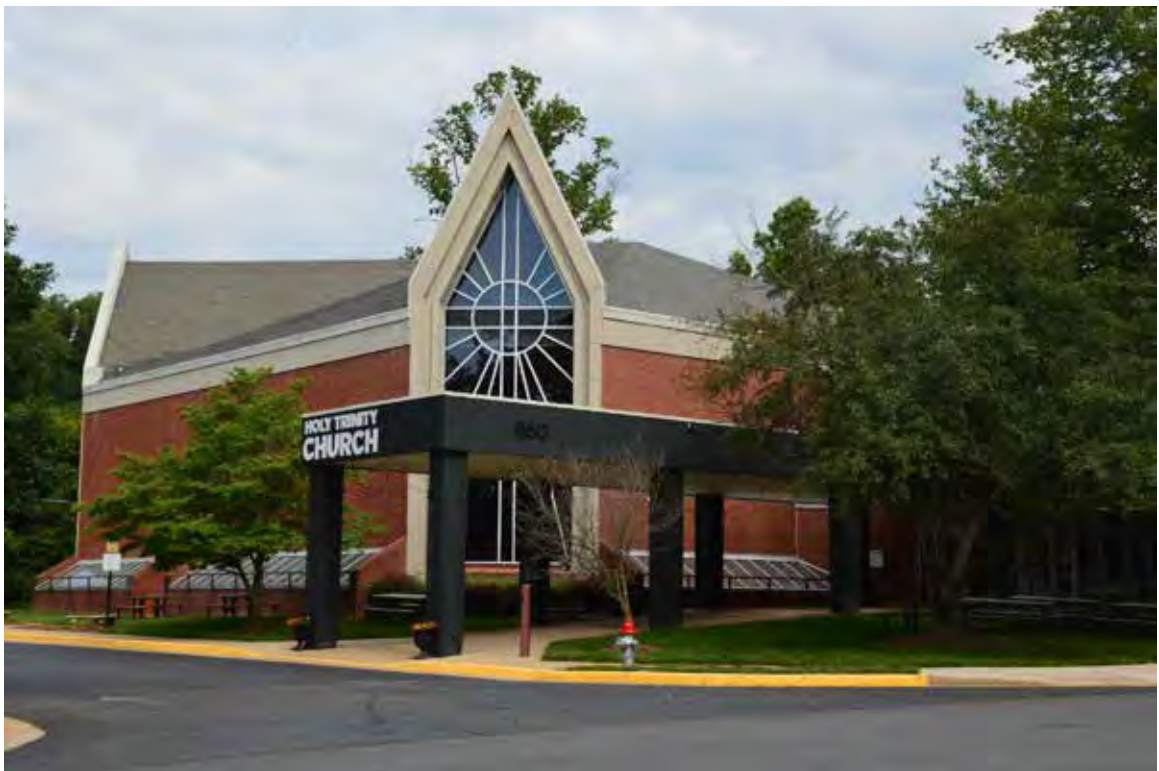
This church consists of an original 1965 core in the northern portion of the building and a large, two-story tall addition built in 1992 on the southern portion (Figure 38). The 1992 addition includes the main entry to the building. The southern portion has a stretcher bond exterior and a hipped asphalt roof with two steeply pitched dormers at the southwest and southeast corners that extend to ground level with large stained glass windows. The other windows are fixed, aluminum

Figure 38. Holy Trinity Church, 850 Balls Hill Road (029-6546), church, entry into 1992 addition.

sash. A flat-roofed porch with large square posts leads to the entry vestibule on the west side of the addition. The original portion of the building is two stories tall and also has a stretcher bond exterior. There is a decorative vertical panel of brick on the northern gable end of the core. The side-gabled roof is covered with asphalt shingles. A vestibule, enclosed with ribbon windows, is on the north elevation and extends into a shed roof porch supported with square wood posts. The windows are fixed, metal sash.

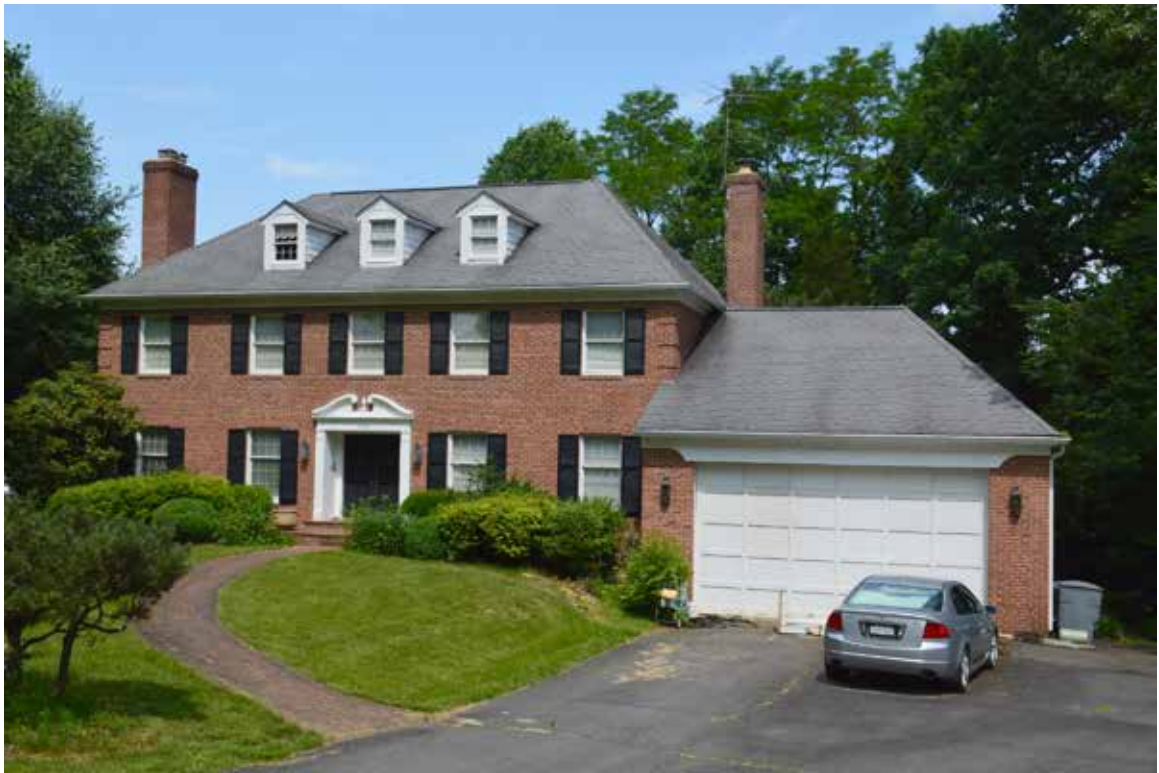
This two-story tall Colonial Revival style house is on a sloping lot, leaving the basement exposed on the north side of the façade (Figure 49). The core measures five bays wide and two bays deep.

Figure 49. 1034 Delf Drive (029-6555), house, view southwest.

The exterior is stretcher bond brick with corner quoins. The hipped roof is covered with asphalt shingles and features three gabled dormers on the front roof slope. The eaves have dentil molding. Adjoining the northern gable end is a one-story tall, two car garage that shares the exterior details of the core. Exterior, stretcher bond chimneys rise up the northern and southern gable ends. The main entry is a double door flanked by fluted pilasters and topped with a broken ogee pediment. The windows are one-over-one, double-hung sash with rowlock sills. The second floor windows abut the eaves.

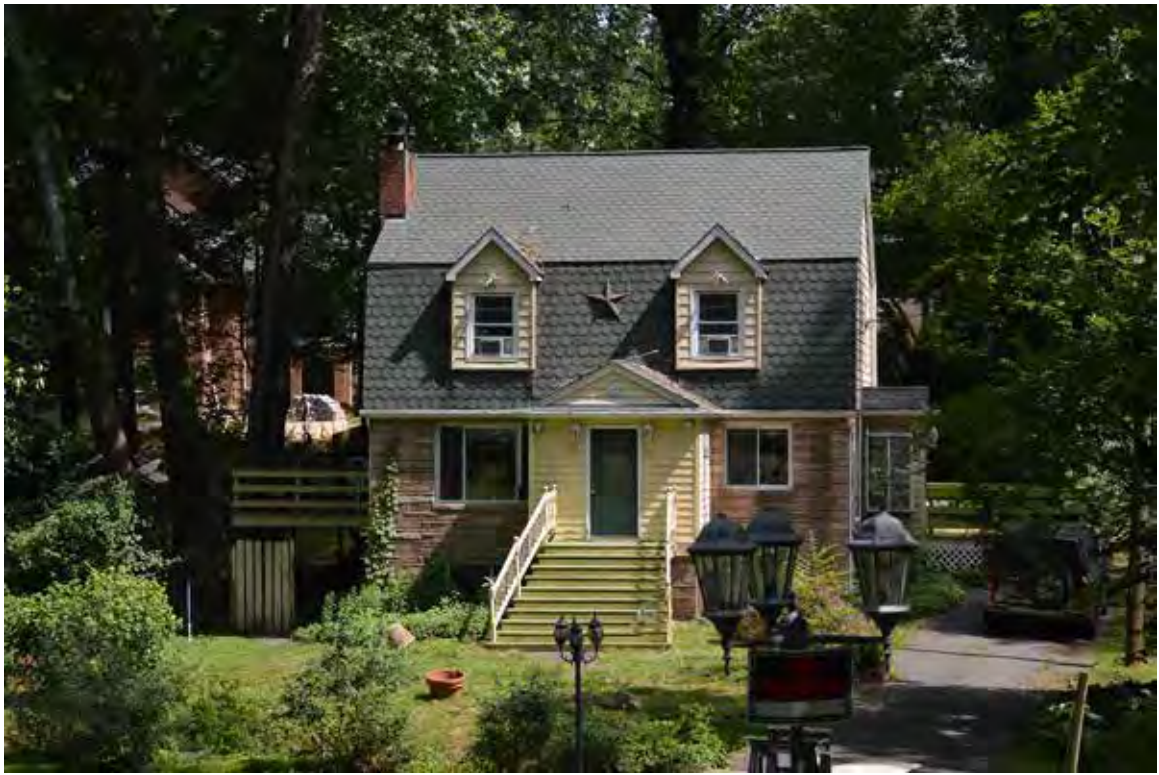
This one-and-one-half story tall Dutch Colonial Revival house has a rectangular core that measures three bays wide and two bays deep (Figure 59). The façade is PermaStone with vinyl siding in the gambrel ends. The gambrel roof is covered with asphalt shingles and features two gable dormers on the front roof slope. An exterior, PermaStone chimney rises up the western

Figure 59. 7400 Old Dominion Drive (029-6565), house, view northwest.

elevation. There is a gabled vestibule centered on the façade that is reached by a tall flight of wooden stairs with a turned balustrade. The windows are a mixture of one-over-one, double-hung sash and picture windows. A wooden deck, with board railing, wraps around the west, north, and east elevations of the house.

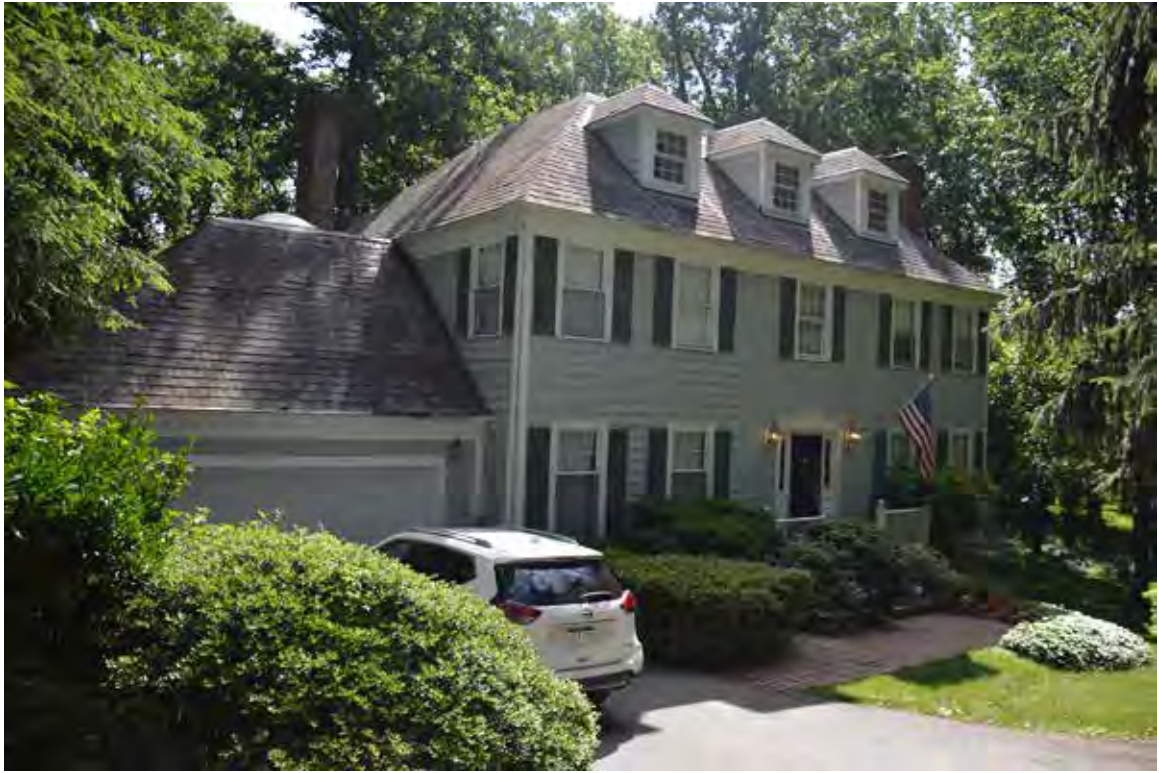
Figure 60. 7514 Old Dominion Drive (029-6568), house, view to northeast.

This two-story tall Colonial Revival style house has a rectangular core measuring five bays wide and two bays deep (Figure 60). The exterior is aluminum siding. The hipped roof is covered with asphalt shingles and features decorative dentil molding along the eaves. Three hipped dormers are found on the front roof slope. Adjoining the western gable end is a one-story tall, two car garage that shares the exterior details of the core. Exterior, stretcher bond chimneys rise up the eastern and western elevations. The main entry is a flanked by sidelights. The windows are one-over-one, double-hung sash. The second floor windows abut the eaves.

According to Fairfax County property assessment records, this building was built in 1978. It is not a significant example of the Colonial Revival style, as it has typical details such as the symmetrical core and hipped roof with hipped dormers. This building is recommended as not eligible under Criterion C of the NRHP. It is not known to be associated with significant events or persons, and as an architectural resource is not recommended eligible under Criterion D.

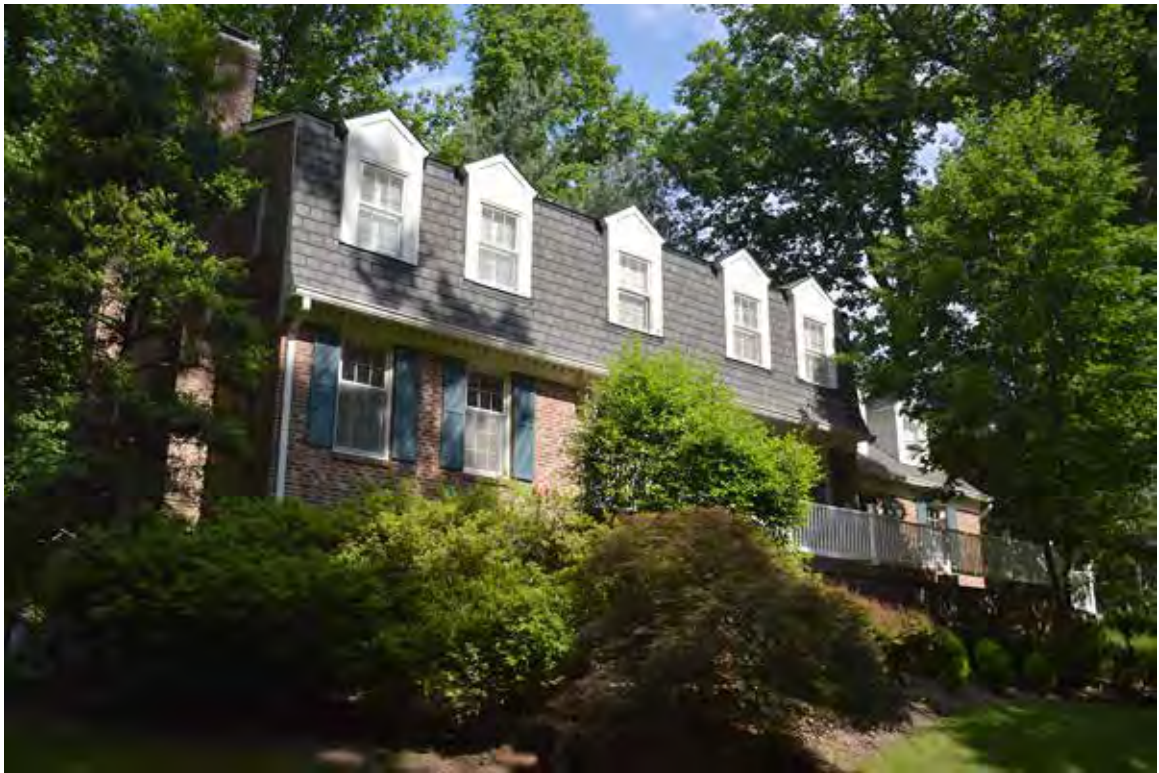
Figure 61. 7518 Old Dominion Drive (029-6569), house, façade.

This one-and-one-half story tall Dutch Colonial Revival house stands on a sloping lot that leaves the basement of the south elevation exposed (Figure 61). The rectangular core measures five bays wide and two bays deep. The elevation is stretcher bond brick. The gambrel roof is covered with asphalt shingles and features five wall dormers on the front and rear roof slopes. Decorative dentil molding runs along the eaves. Two stretcher bond brick, exterior chimneys rise up the southern elevation. A one-and-one-half story tall, two-car garage adjoins the eastern elevation of the core. The garage features a stretcher bond exterior and side-gabled roof covered with asphalt shingles and two gable dormers on the front roof slope. The windows are one-over-one, double-hung sash with rowlock sills and faux muntins.

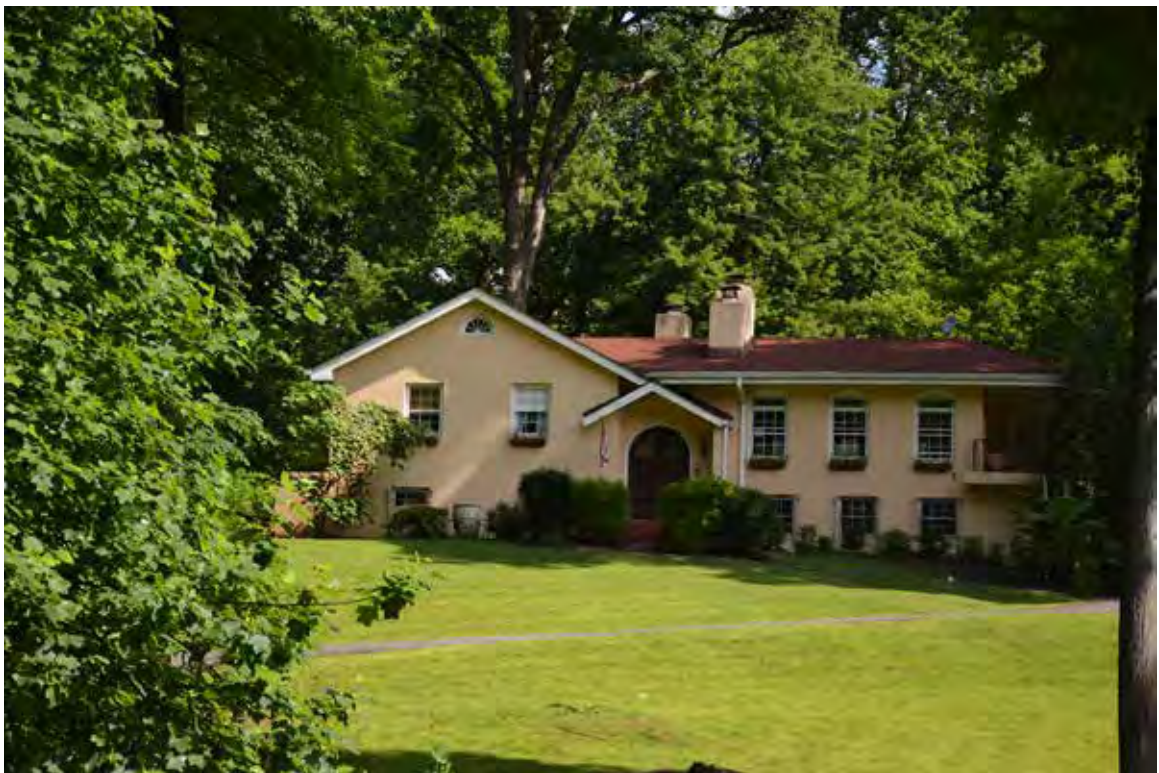
Figure 62. 7536 Old Dominion Drive (029-6570), house, façade.

This split foyer house has a rectangular plan that measures six bays wide and three bays deep, with the main entry at mid-height between the two floors (Figure 62). The exterior is stucco and the cross gabled roof is covered with asphalt shingles. There are two stucco chimneys rising through the center of the roof. The main entry is reached by a flight of brick stairs and is sheltered by a gabled hood. The windows are one-over-one, double-hung sash with faux muntins. An inset porch with cast metal railing is found on the southwest corner of the second floor.
