CULTURAL RESOURCES SURVEY FOR THE INTERSTATE 495 EXPRESS LANES NORTHERN EXTENSION PROJECT

VDOT PROJECT: 0495-029-419, P101
IPM/UPC/CSC NO: 113414
VDHR FILE NO: 2018-0473

FAIRFAX COUNTY, VIRGINIA

FINAL REPORT
JUNE 2019

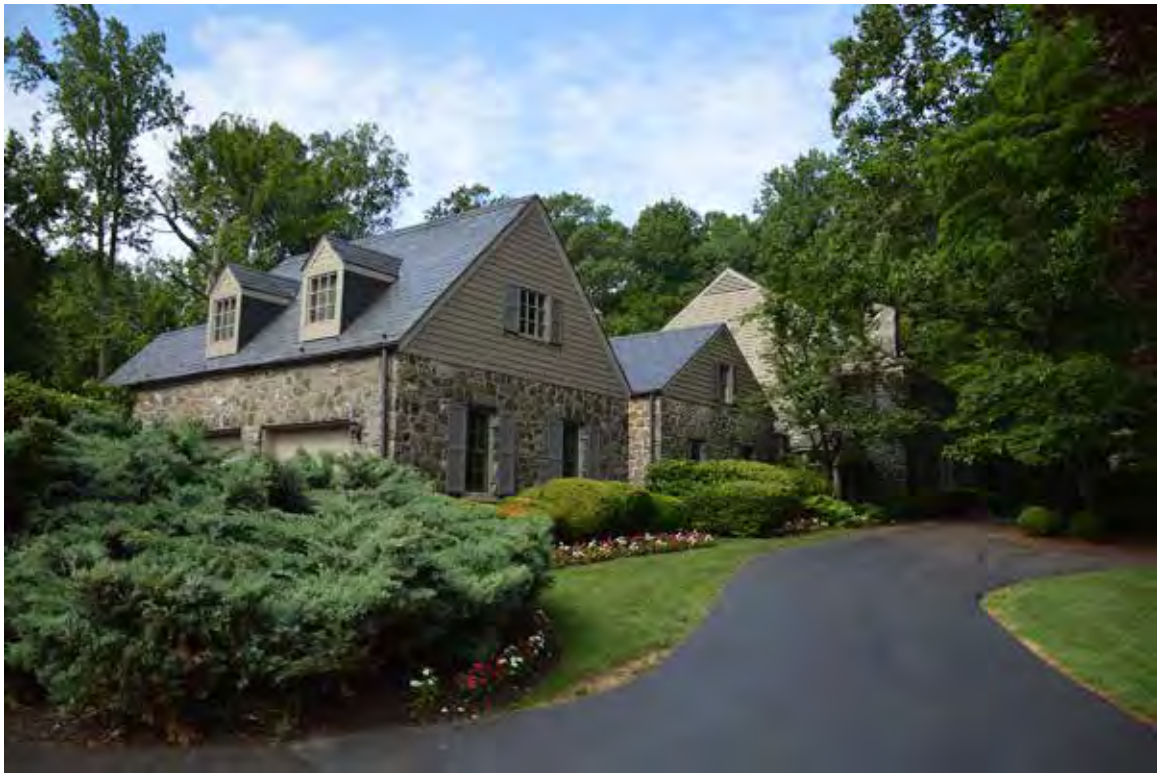
Figure 63. 7527 Old Dominion Drive (029-6573), house, northeast corner.

This two-story tall Colonial Revival style house has a two-story, rectangular plan core that measures five bays wide and two bays deep (Figure 63). The exterior is rubble stone with weatherboard in the gable ends. The side-gabled roof is covered with slate shingles. There are one-and-one-half story tall, front gabled wings extending from the west and east gable ends. Then on the western wing, there is another front gabled ell. On the east side of the east wing is a front-gabled, one-and-one-half story tall three-car garage. These wings share similar exterior details as the core. An exterior, rubble stone chimney rises up the western gable end of the core. The windows are six-over-six, double-hung sash, with a projecting bay window on the northeast corner of the core. The main entry is set within a deep recess.

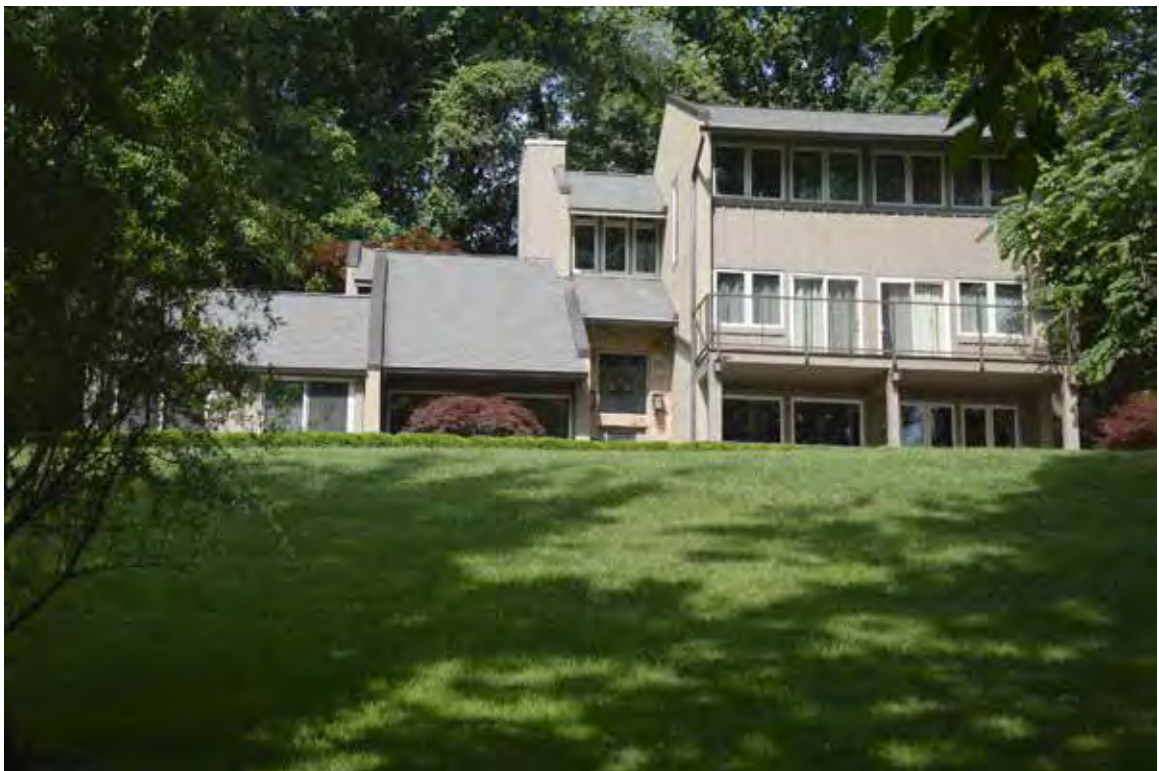
This two-story tall Contemporary house stands on a sloping lot that leaves the basement exposed on the east elevation (Figure 64). The form of this house is complex, with several sections varying from one-and-one-half to one story tall. A one-story wing extends from the north gable end and houses a two car garage. The exterior of the house is stucco and board-and-batten siding. The complex, side-gable roof is covered with asphalt shingles with short parapets between the various roof sections. A board-and-batten chimney rises through rear roof slope. The windows are casement sash, with many of them hung in groups. A balcony, with wire railing, extends along the east elevation from the first floor.

Figure 64. 7515 Old Dominion Drive (029-6572), house, façade.

According to Fairfax County property assessment records this house was built in 1973. This house has typical features of the Contemporary style, including stucco exterior, varying rooflines, and grouped windows. This building is recommended as not eligible under Criterion C of the NRHP. It is not known to be associated with significant events or persons, and as an architectural resource is not recommended eligible under Criterion D.

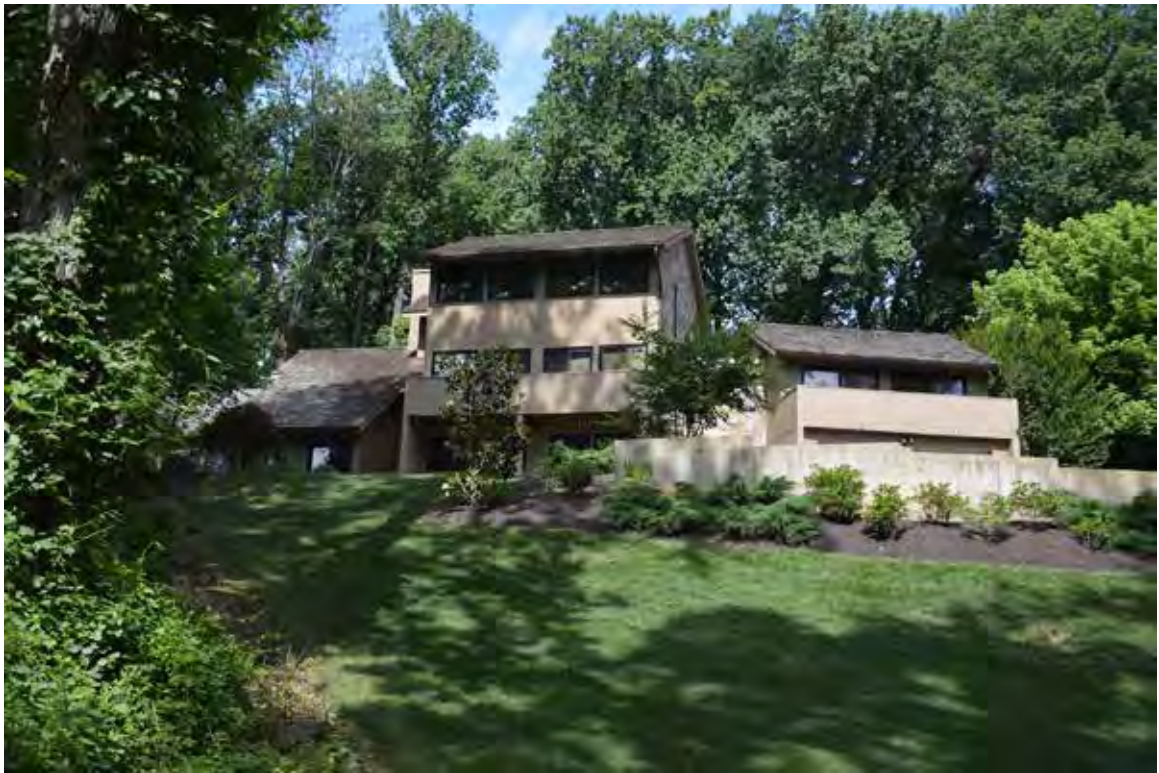
Figure 65. 7513 Old Dominion Drive (029-6571), house, façade.

This two-story tall Contemporary house stands on a sloping lot that leaves the basement exposed on the east elevation (Figure 65). The form of this house is complex, with several sections varying from one-and-one-half to one story tall. A one-story wing extends from the north gable end and houses a two-car garage. The exterior of the house is stucco and rubble stone cladding. The complex, side-gable roof is covered with asphalt shingles with short parapets between the various roof sections. A stucco chimney rises through rear roof slope. The windows are casement sash, with many of them hung in groups. A balcony, with stucco balustrade, extends along the east elevation from the first floor.

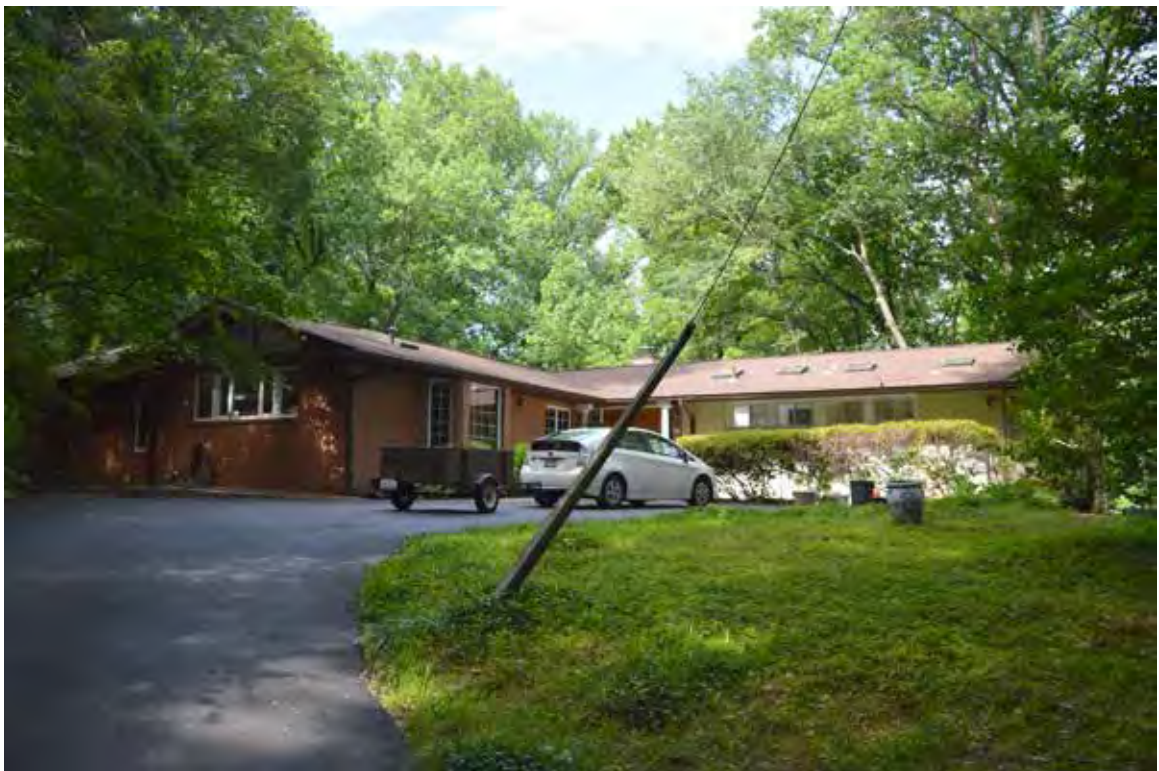
Figure 66. 7409 Old Dominion Drive (029-6567), house, view southwest.

This core of this house is a one-story tall Ranch style house that has a rectangular plan that measures five bays wide and two bays deep (Figure 66). The exterior of the house is stretcher bond brick. A gabled ell extends from the southern bay of the core's façade. This ell measures three bays wide and two bays deep. The side gabled roof is covered with asphalt shingles and features several skylights. A stucco chimney rises through the rear roof slope. An inset porch, supported by round columns, on the core shelters the front entry. The windows are a mixture of sliding sash and casement windows, some with rowlock sills.

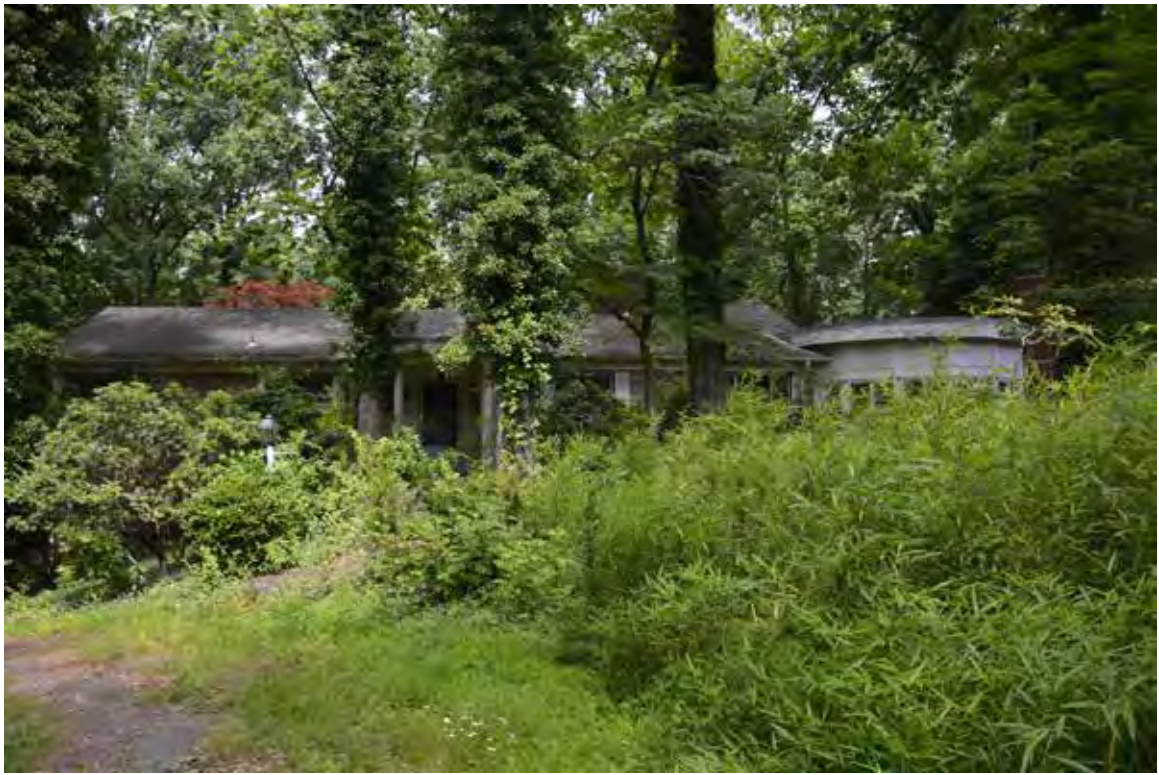
Figure 69. 7441 Dulany Drive (029-6574), house, façade.

This one-story tall Ranch style house has a rectangular plan that measures six bays wide and two bays deep (Figure 69). The exterior is stretcher bond brick. The low-pitched side-gabled roof is covered with asphalt shingles and features a wide, stretcher bond chimney rising through the center of the roof ridge. The northern bay of the core has a one-story tall polygonal bay with a flat roof. A semi-circular entry porch with square posts shelters the front entry. The windows are one-over-one, double-hung sash with rowlock sills. A picture window is also found on the façade.

According to Fairfax County property assessment records, this building was built in 1955. It is not a significant example of the Ranch style, as it has typical details such as the one-story tall rectangular form, low-pitched side-gabled roof, stretcher bond exterior, and few architectural details. This building is recommended as not eligible under Criterion C of the NRHP. It is not known to be associated with significant events or persons, and as an architectural resource is not recommended eligible under Criterion D.

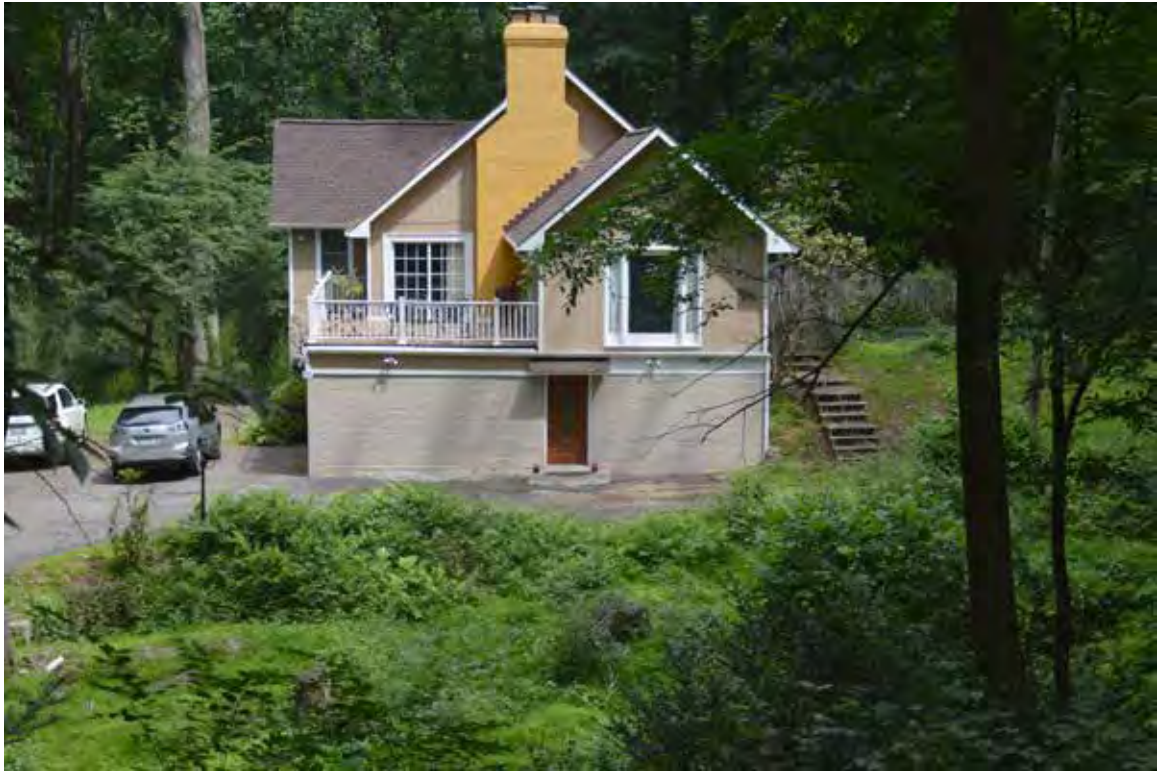
Figure 70. 7437 Dulany Drive (029-6575), house, view west.

This one-story tall, frame Minimal Traditional style house has a T-plan core that measures four bays wide and three bays deep, with a one-bay wide ell on the eastern gable end (Figure 70). The exterior of the house is T-111 siding. The exposed basement is stretcher bond brick. A stretcher bond brick chimney rises up the eastern gable end. The windows are a mixture of one-over-one, double-hung sash and fixed sash.

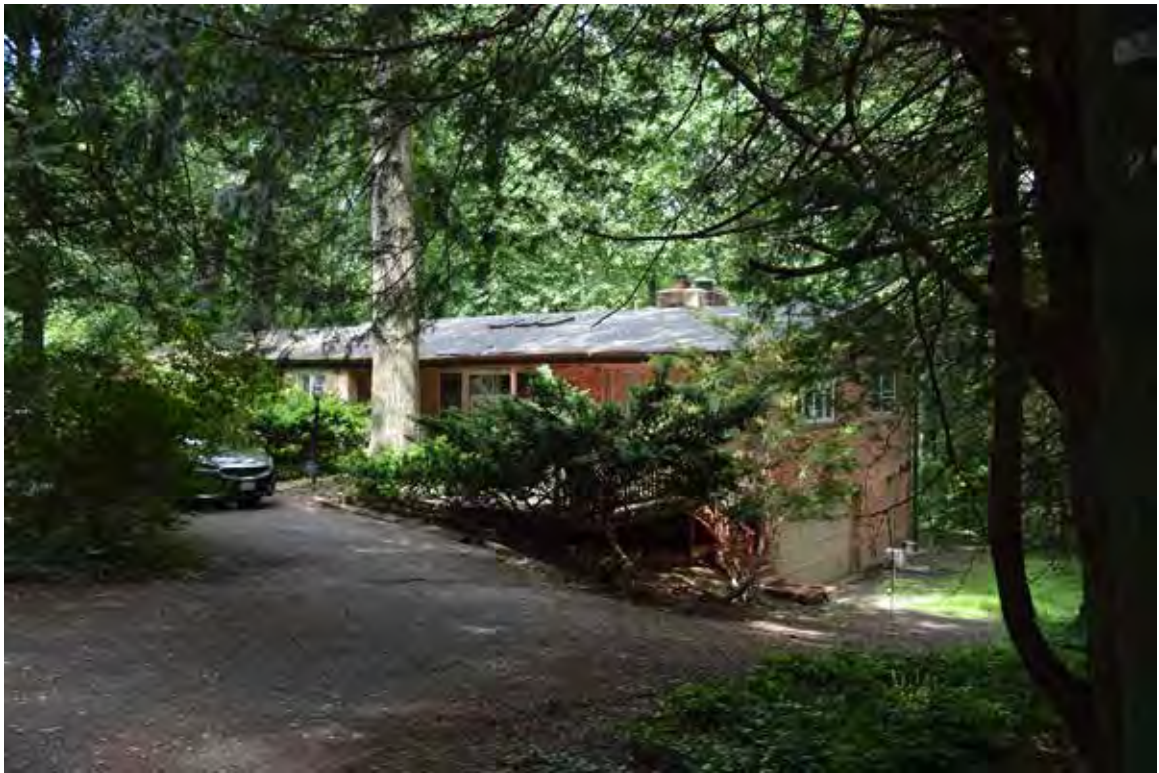
Figure 71. 7433 Dulany Drive (029-6576), house, view southwest.

This one-story tall Ranch style house has a rectangular plan that measures six bays wide and two bays deep (Figure 71). The sloping lot exposes the basement on the northern gable end. A two car garage is found on the western elevation of the basement. The exterior is stretcher bond brick. The low-pitched side-gable roof is covered with asphalt shingles. A wide, stretcher bond brick chimney rises through the rear roof slope. An inset porch shelters the front entry. This porch has cast metal supports. The windows include one-over-one, double-hung sash and picture windows; all windows have rowlock sills.

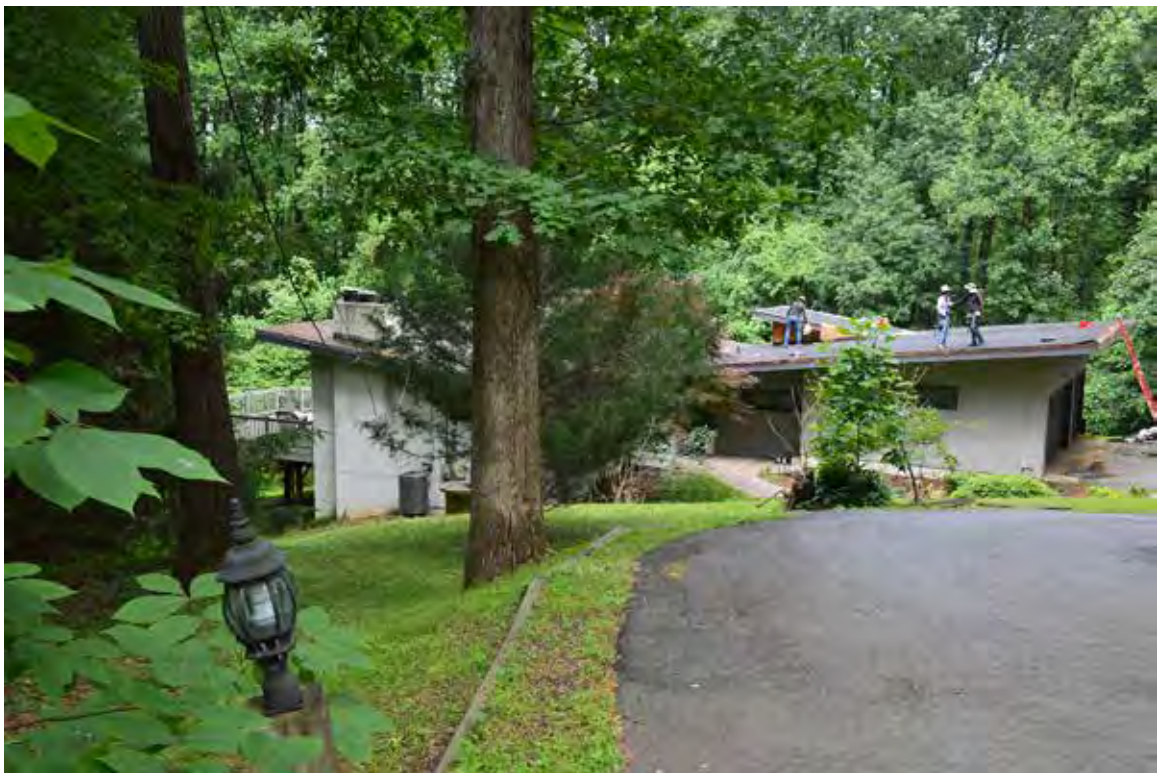
Figure 72. 7425 Dulany Drive (029-6577), house, view southwest.

This one-story tall Contemporary, frame house has an irregular plan and V-shaped roof (Figure 72). The exterior of the house is T-111 siding on the northern portion and stretcher bond brick on the southern portion. The roof is asphalt with a shed roof clerestory window on the southern portion. A wide, stretcher bond chimney rises along the eastern elevation. The windows are a mixture of fixed sash and casement windows. The northern portion of the house is a three-car garage.

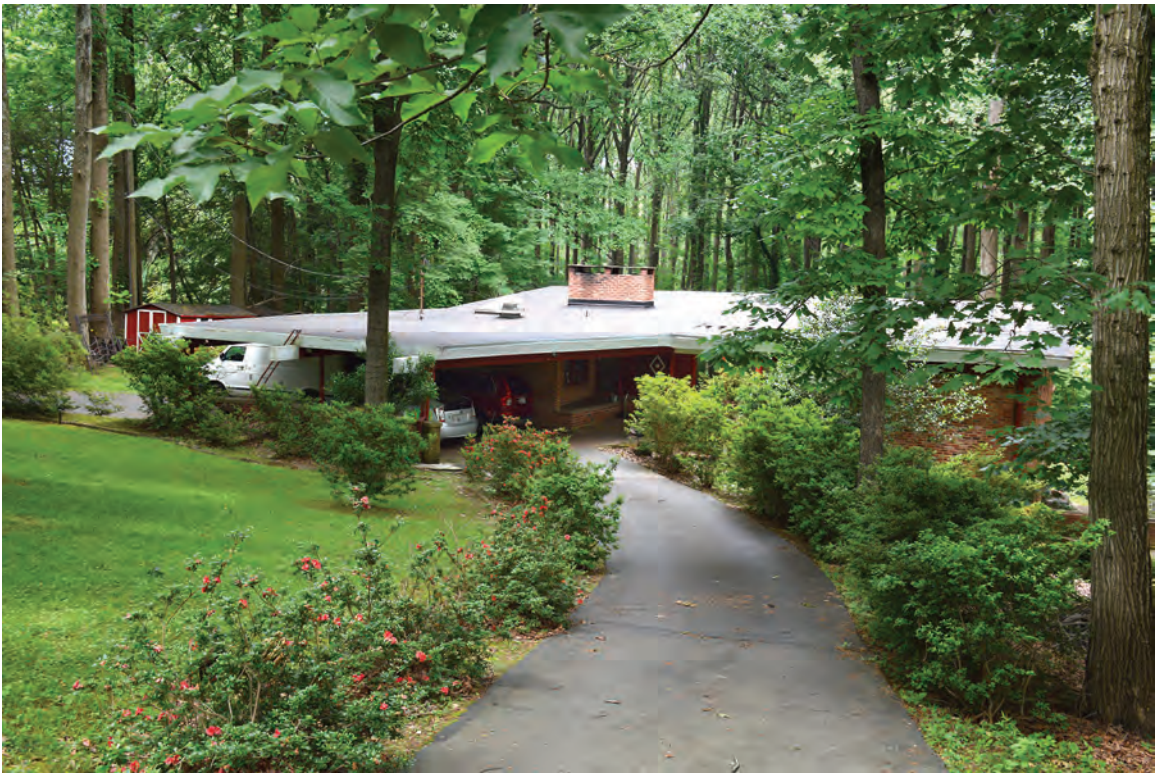
Figure 73. 7421 Dulany Drive (029-6578), house and shed, view south.

This one-story tall Contemporary, frame house has an irregular plan and V-shaped roof (Figure 73). The exterior of the house is stretcher bond brick. The eastern portion of the house is an open carport with exposed rafter ends. The roof is asphalt with a wide, stretcher bond chimney rising through the center of the roof. The windows are a mixture of fixed sash and casement windows. The recessed main entry includes a built-in, stretcher bond planting box.

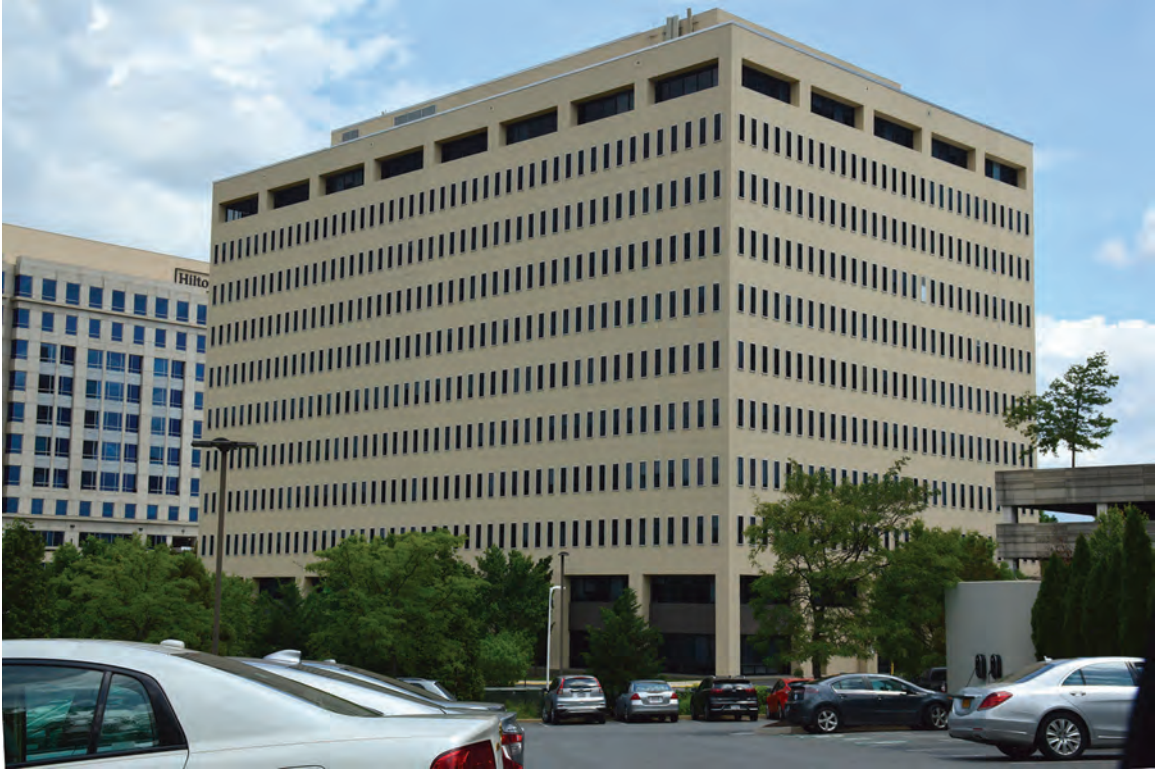
Figure 74. Office building, 7926 Jones Branch Drive (029-6579), view southeast.

This eleven-story office building has a square plan with a slightly recessed ground floor (Figure 74). The exterior is stucco panels and the roof is a flat, parapet roof. The ground level has ribbons of windows between square supports. The second through tenth floors are lit by narrow, rectangular fixed sash, while the top floor has larger, recessed ribbon windows.

According to Fairfax County property assessment records, this building was built in 1975. It is a typical commercial style office building, with simple form and detail. This building is recommended as not eligible under Criterion C of the NRHP. It is not known to be associated with significant events or persons, and as an architectural resource is not recommended eligible under Criterion D.
